# Manhole Inspection Summary

Manhole # S47G\_\_005MH

Insp Date: **7/9/08 12:05 PM**

**Location** Address: **Collington**

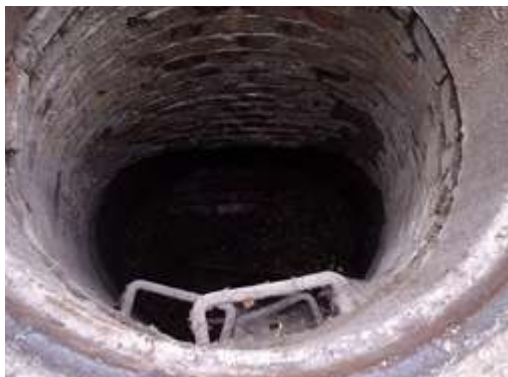
Defect 2

**Frame** Offset: **1** (in.) Condition: ☐ Sound ☐ Cracked ☒ **Leaks**

frame leaks

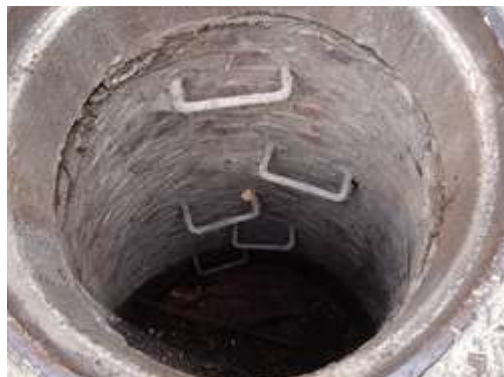
Defect 1

Infiltration: ☐ None ☒ **Joint** ☐ Cracks ☒ **Mortar** ☐ Roots ☒ **Wall**

infiltration

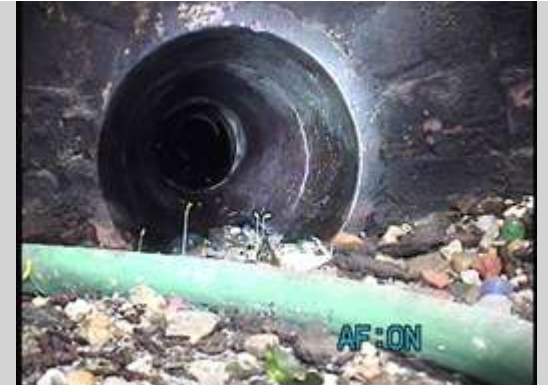
12 O'Clock Outflow

8 in. Circular Gravity Sewer  
Pipe Out @ 12 O'Clock

Infiltration: **None** Pipe Seal Cond: **Sound**
